# Manhole Inspection Summary

Manhole # S51A\_\_003MH

Insp Date: **5/5/08 2:31 PM**

**Location** Address: **rear 226 n.kenwood ave**

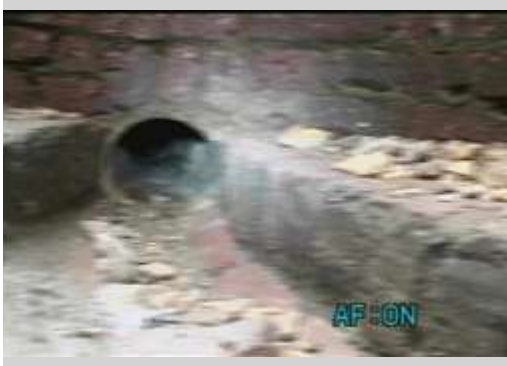
Defect 3

Condition: ☐ Sound ☐ Cracked ☐ Root Intrusion ☐ Deteriorated ☐ Leaks ☒ **Debris**

Channel Debris

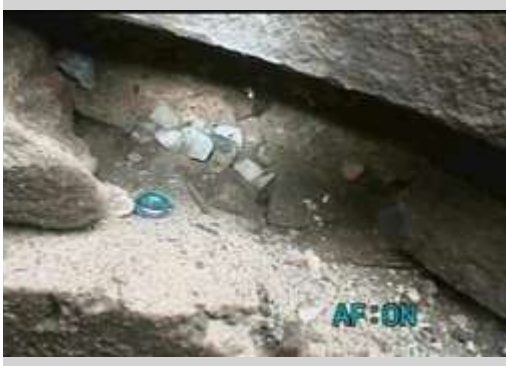
Defect 2

Condition: ☐ Sound ☐ Cracked ☐ Root Intrusion ☒ **Loose Brick** ☒ **Deteriorated**

missing/loose brick, deterioration, frame adj

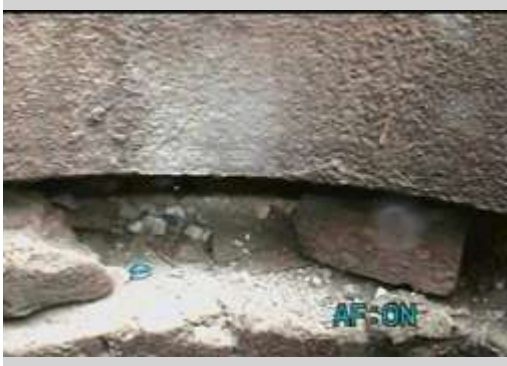
Defect 1

**Frame** Offset: **2** (in.) Condition: ☒ Sound ☐ Cracked ☐ Leaks

offset

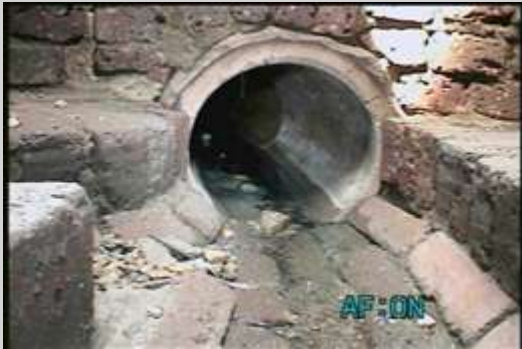
12 O'Clock Outflow

8 in. Circular Gravity Sewer  
Pipe In @ 12 O'Clock

Pipe Material: **Clay** ☐ Pipe Lined

Invert Depth: **5.30** (ft.) Flow Characteristics: **Slow**

Deposits: ☒ None ☐ Mud ☐ Sludge ☐ Debris ☐ Grease

Infiltration: **None** Pipe Seal Cond: **Unknown**

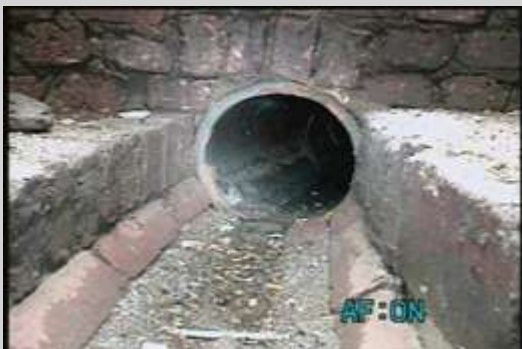
6 O'Clock Inflow

8 in. Circular Gravity Sewer  
Pipe Out @ 6 O'Clock

Pipe Material: **Clay** ☐ Pipe Lined

Invert Depth: **5.05** (ft.) Flow Characteristics: **Slow**

Deposits: ☒ None ☐ Mud ☐ Sludge ☐ Debris ☐ Grease

Infiltration: **None** Pipe Seal Cond: **Unknown**

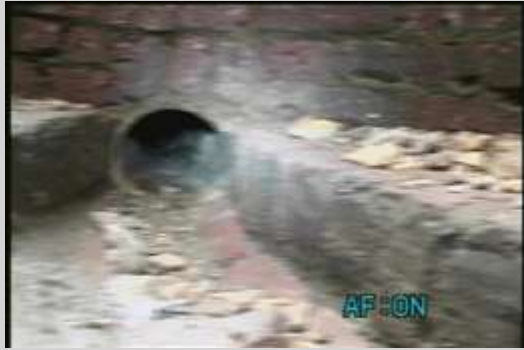
9 O'Clock Inflow

6 in. Circular Gravity Sewer

Pipe In @ 9 O'Clock

Pipe Material: **Clay** ☐ Pipe Lined

Invert Depth: **5.07** (ft.) Flow Characteristics: **None**

Connects To: **Dead End**
